ERDC/CERL TR-01-6

Demonstration of Anti-Scale Corrosion Resistant Coatings for Hot Water Heat Exchangers

January 2001

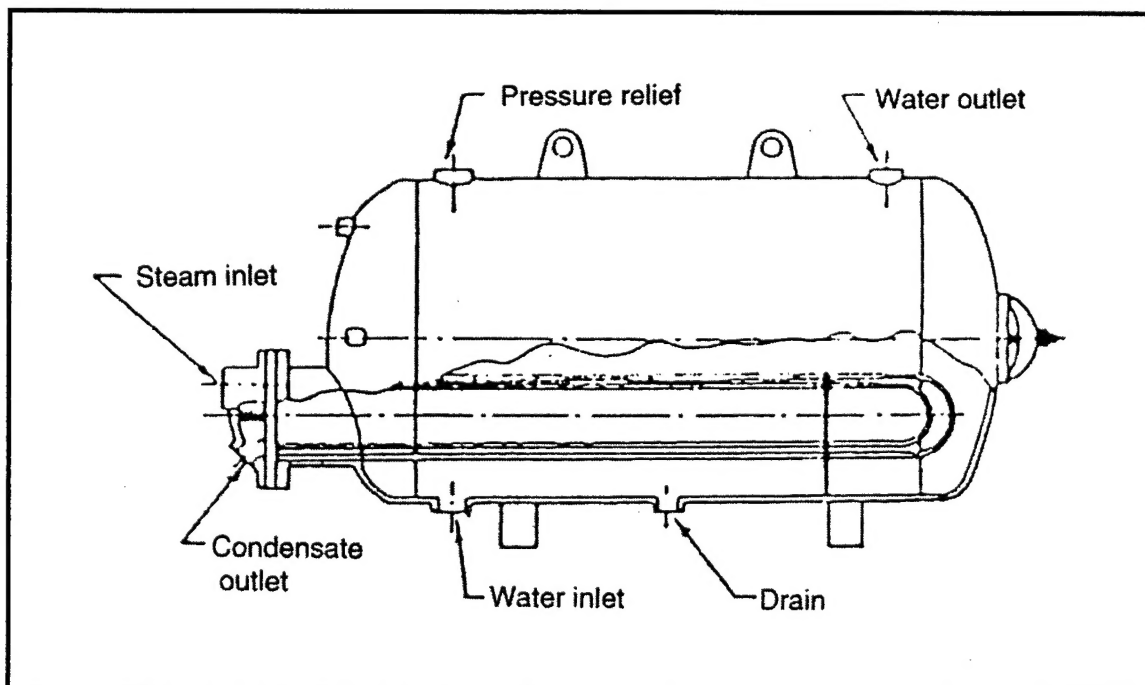
A heat exchanger system commonly used in the Army is the domestic water storage heater (DWSH) (Figure 1). The system is composed of a cylindrical steel reservoir lined with concrete for corrosion protection. A water inlet at the bottom provides access to a U-tube bundle assembly. At Fort Hood, this assembly is 71.5 in. long and has 13 individual tubes of copper alloy with a surface area of 29.7 sq ft. By sustaining a large hot water reservoir, the system can provide sufficient hot water during the times of peak demand. Typical facilities that use these systems are dining halls, barracks, and laundries.

Figure 1. Domestic hot water storage heater.

Steam or hot water is circulated through the interior of the tube bundles. Heat is transferred from the steam through the copper pipe wall and into the domestic water medium. The domestic water enters the reservoir at one end beneath the U-tube assembly and exits at the top. This path provides the greatest amount of thermal exposure to maximize heat transfer. Under normal conditions at Fort Hood, the inlet waters at buildings (Bldg.) 29006 and 87017 enter the respective reservoirs at 60 to 70 °F and exit the top at 140 to 160 °F.

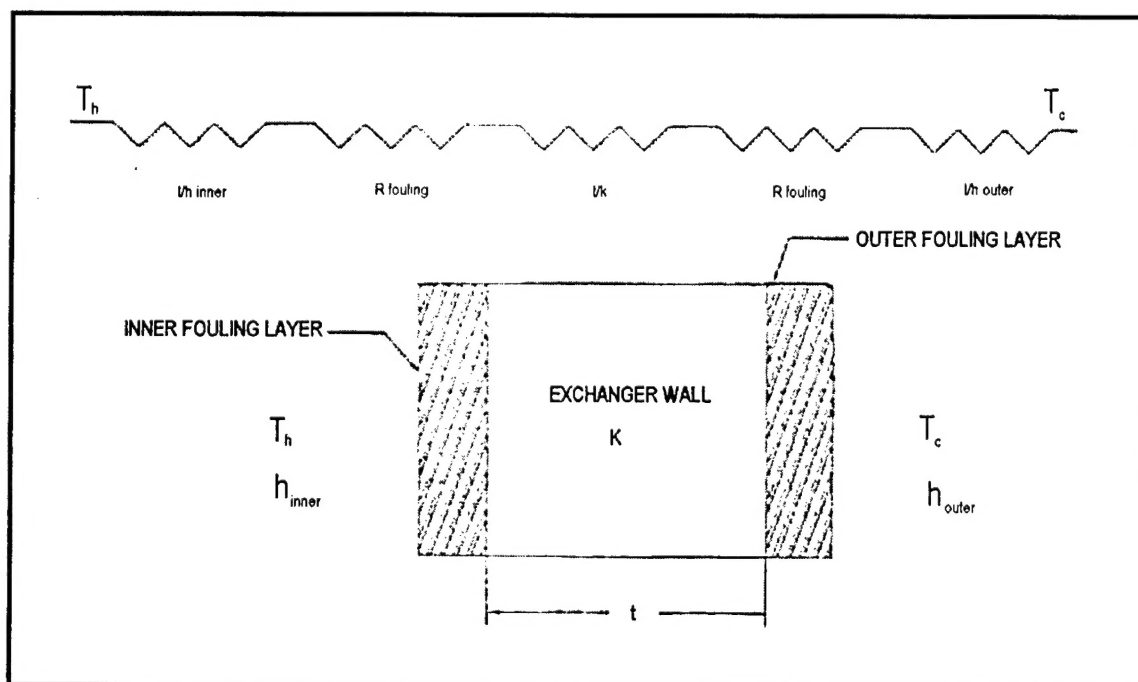
Using these factors, it is possible to construct an overall expression of resistance to heat flow in the heat exchanger. It is important to note that heat flow resistance contributed by a coating would take a form similar to that of the fouling-induced resistances $R_{f,h}$ and $R_{f,c}$.

Figure 2. Thermal barriers on heat exchanger tube.

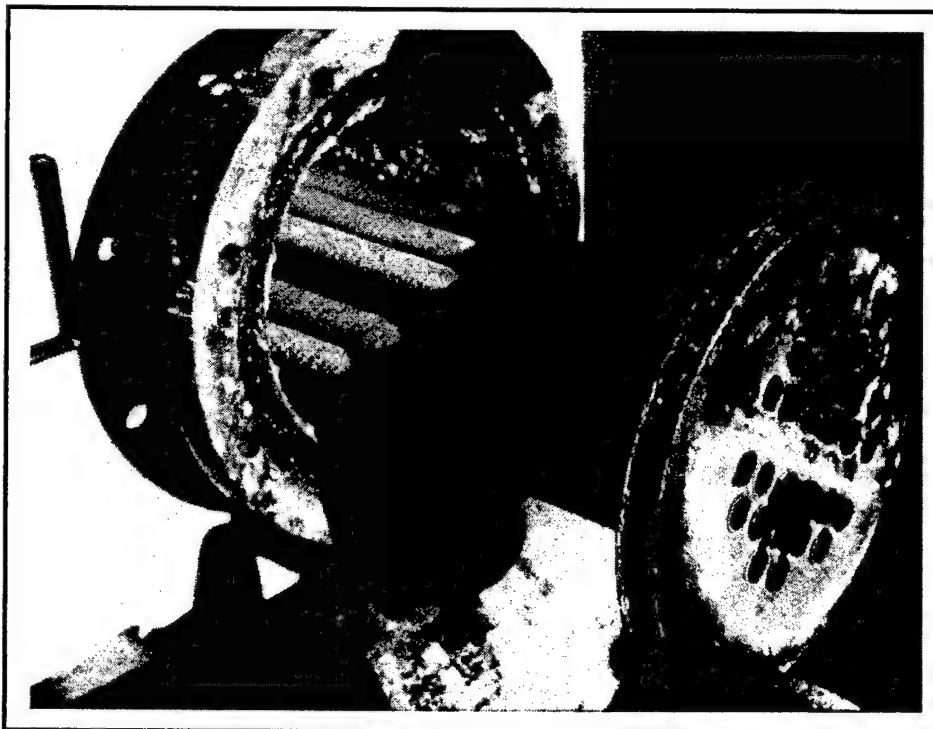
In March 1986, Fort Hood, TX, personnel reported continuing problems with scale forming on the surfaces of copper tube bundles in domestic hot water heaters. During a May 1986 site visit, investigators examined a water storage heater located in a dining facility (Building 29006). The cement-lined tank has a capacity of 2115 gal. Typical daily hot water use is 11,000 gal. Recurrent difficulties were reported in sustaining the dining hall hot water supply above the required 140 °F. When the heat exchanger tube bundles were removed they appeared as shown in Figure 3.

Figure 3. Scaled heat exchanger tube bundle, Fort Hood, TX.

The tube bundle assembly is made of copper and measures 71.5 in. long with a total surface area of 29.7 sq ft. Each of the 13 tubes has an outside diameter of 3/4 in. A 0.07-in. deposit, comprised primarily of calcium carbonate, coated the exterior or water side surfaces of the tubes. The 12 psi steam supply that runs through the tubes is generally adequate for generating the 140 °F service water temperature. However, the presence of the scale layer significantly diminishes the overall heat transfer coefficient of the system. Examination of maintenance records revealed that this heat exchanger had gone 4 months since the last cleaning.

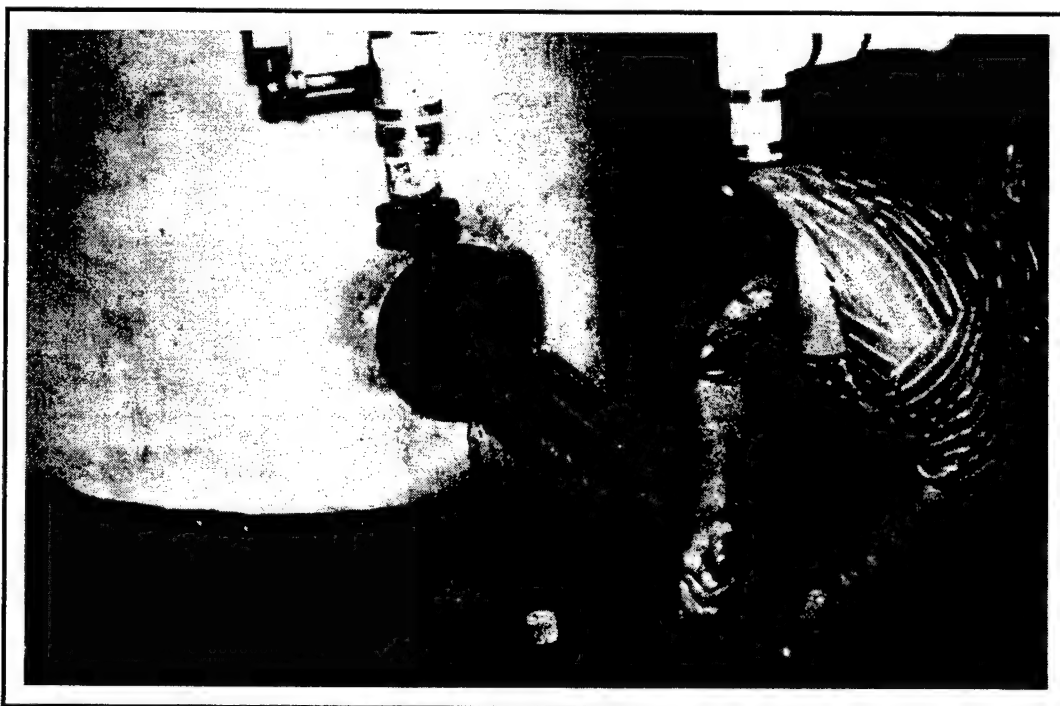
Figure 4. Removal of tube bundle, Bldg D-2248, Fort Bragg, NC.

The heating medium is high temperature hot water at 375 to 385 °F, which flows through the tube bundle and heats the domestic water in the tank to approximately 130 °F. The tube bundles had been in service for approximately 17 yr, and their waterside surfaces were covered with a brownish-colored scale deposit with thicknesses up to 0.14 in. Subsequent energy dispersive spectroscopy and microchemical analysis revealed that the deposit was comprised of calcium carbonate, hydrated hematite ("red rust"), and products containing phosphorus. The source of the hematite was most likely the corrosion of ferrous-based materials upstream from the heaters. This is understandable since the water at Fort Bragg is relatively corrosive. The deposit immediately adjacent to the bundle surface also contained aluminum, zinc, and copper. It is possible that the sources of the phosphorus and aluminum were chemicals used to treat the river water supply.

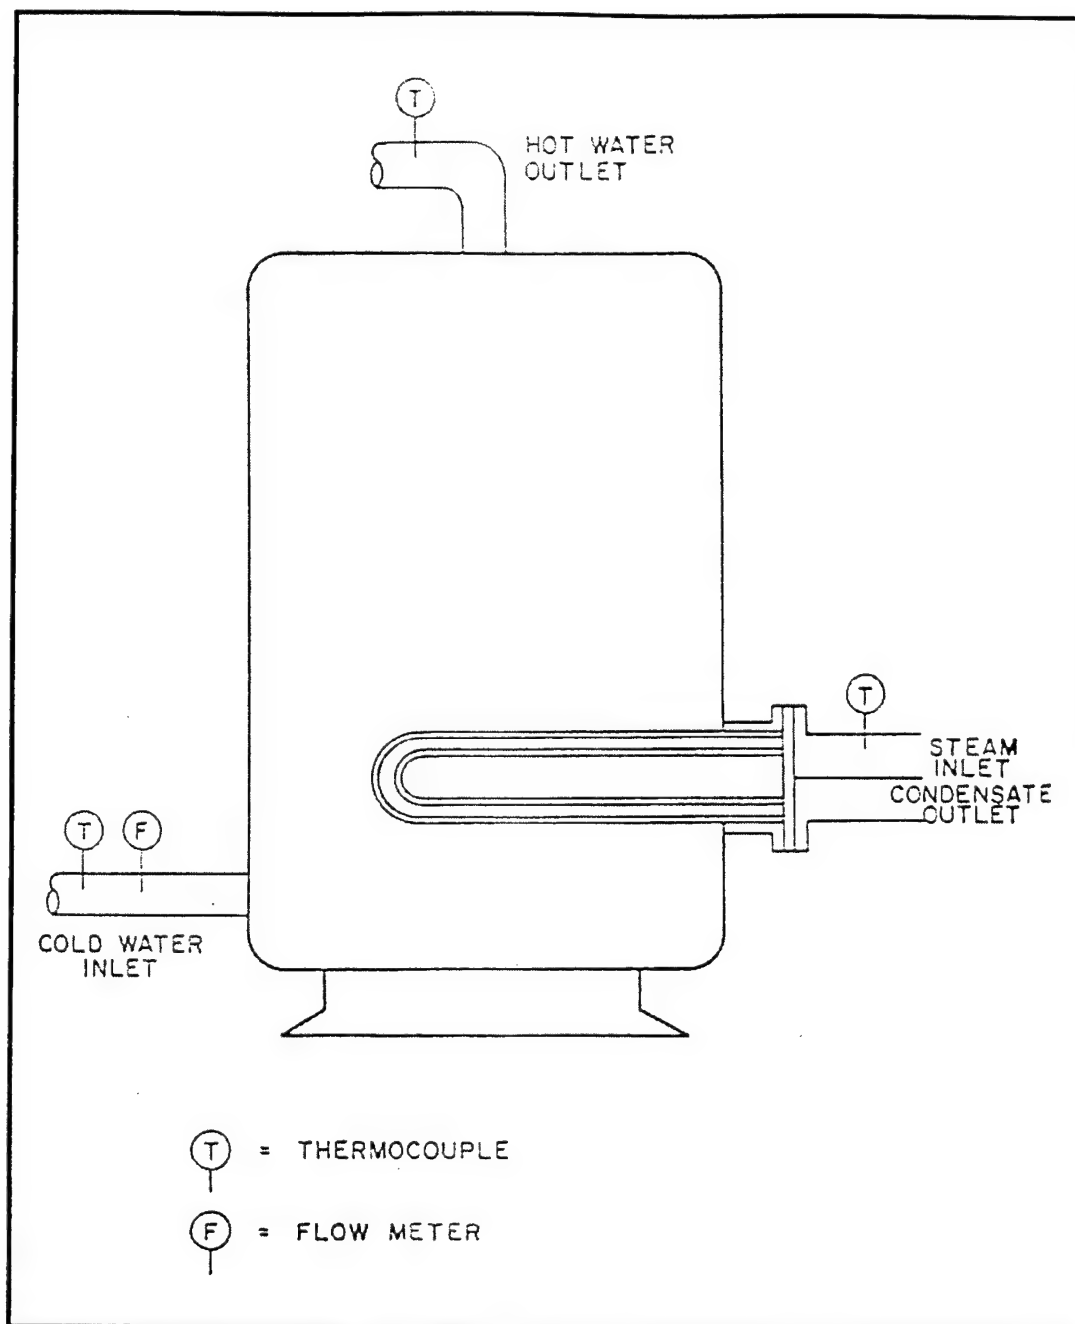
Figure 7. Placement of sensors on heat exchangers.

Because the performance of a heat exchanger may be characterized by the overall heat transfer coefficient (U), the presence of corrosion or scale on a tube surface would cause a reduction in U and hinder the delivery of heat. Over time, the amount of tube fouling renders the heat exchanger unable to deliver hot water at the required temperature despite maintaining a constant full flow of steam or high temperature hot water. Under these circumstances the evaluation of the heat exchanger performance can be conducted by installing a thermocouple at the hot water outlet (as shown in Figure 7) and monitoring the hot water exit (T_h) values. In this case, data was collected continuously on a data logger and downloaded to disk once a month for analysis.

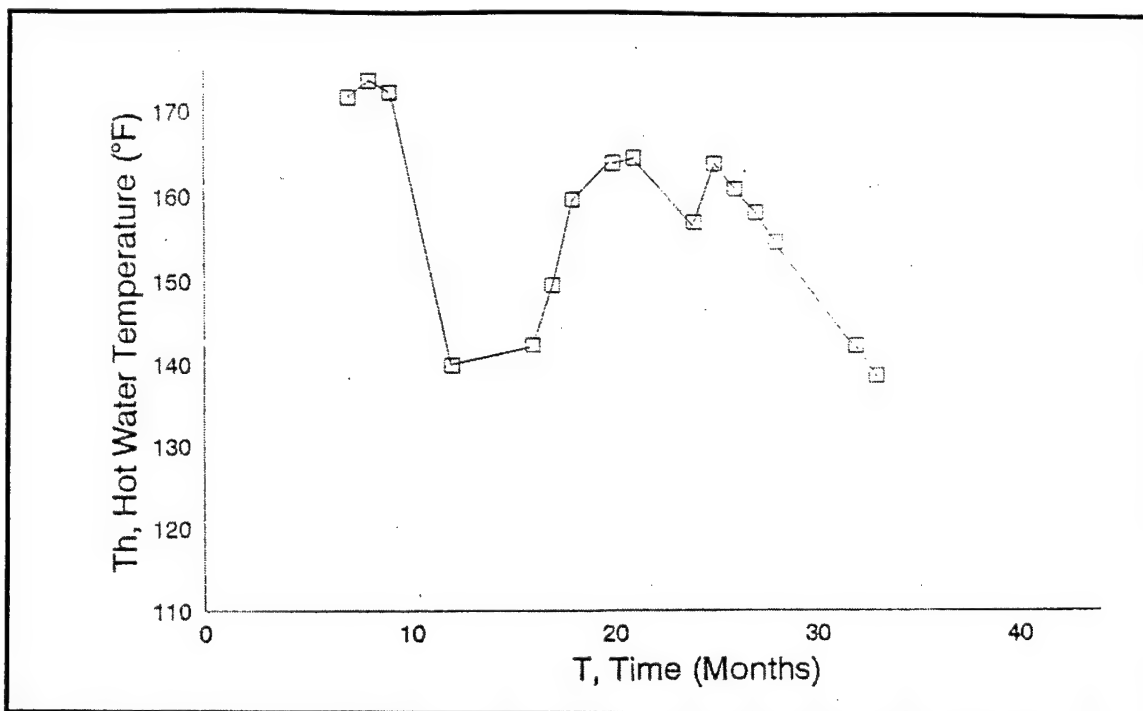
Figures 8 and 9 show field measurements for the hot outlet water temperatures. The data is plotted as monthly averages occurring over a 48-month period starting in May 1988 and ending in May 1992. The average monthly hot water temperature was maintained between 137 and 170 F for Buildings 29006 and 87017 over a 48-month period. Neither of these figures appears to reveal any trend of degradation. However, note that the heat exchanger was removed from Building 29006 on 28 April 1992 to rehabilitate the coating that had failed due to spalling after 4.5 yr of an estimated 5-yr service life.

Figure 8. Hot outlet water temperatures for phenolic-coated heat exchanger, Bldg 29006, Fort Hood, TX.

Completely absent from the hot water outlet patterns (as shown in Figures 8 to 11) of either site is any indication of a negative sloping trend among the hot water delivery values. Additionally, the average hot water temperature was maintained at 140 °F at Fort Hood, and above 147 °F at Fort Lewis. Similarly, the personnel at Fort Bragg have experienced no difficulty in maintaining the 140 °F required hot water temperature. These observations indicate that the scale has not formed on the coated tube bundles at Fort Hood and Fort Bragg and the corrosion fouling did not form on the tube bundles at Fort Lewis. For Fort Hood Building 87017 in particular, this finding means that a 90-day cycle of acid cleaning may be replaced by a one-time fix that has provided over 4 yr of satisfactory performance.

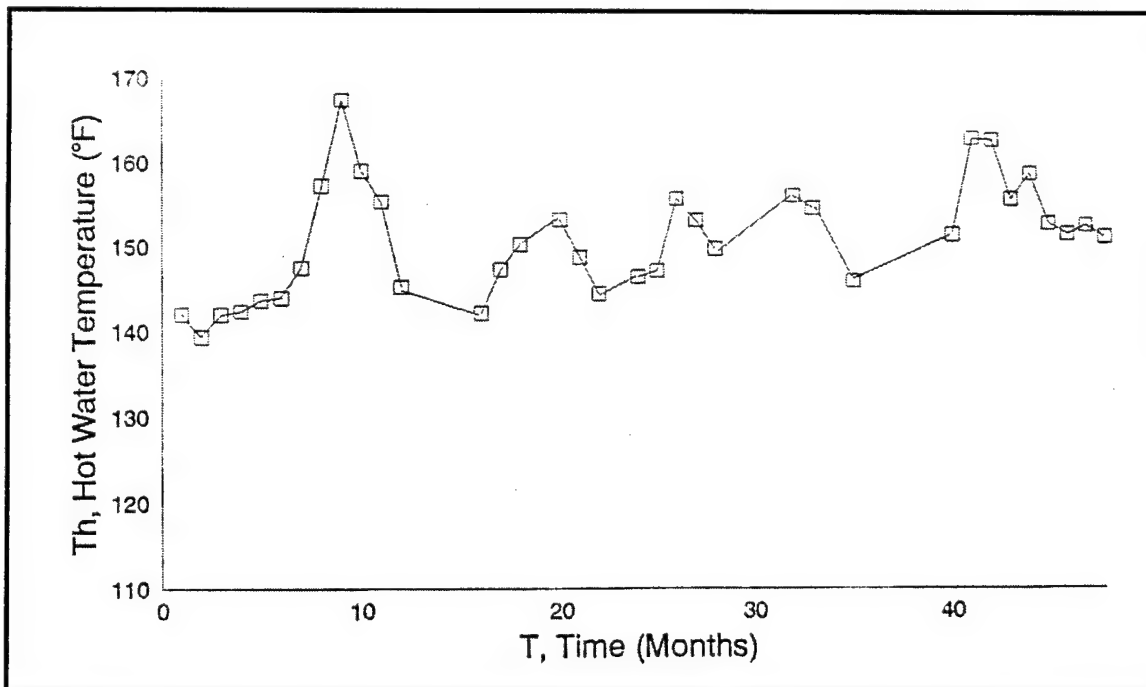
Figure 9. Hot outlet water temperatures for phenolic-coated heat exchanger, Bldg 87017, Fort Hood, TX.

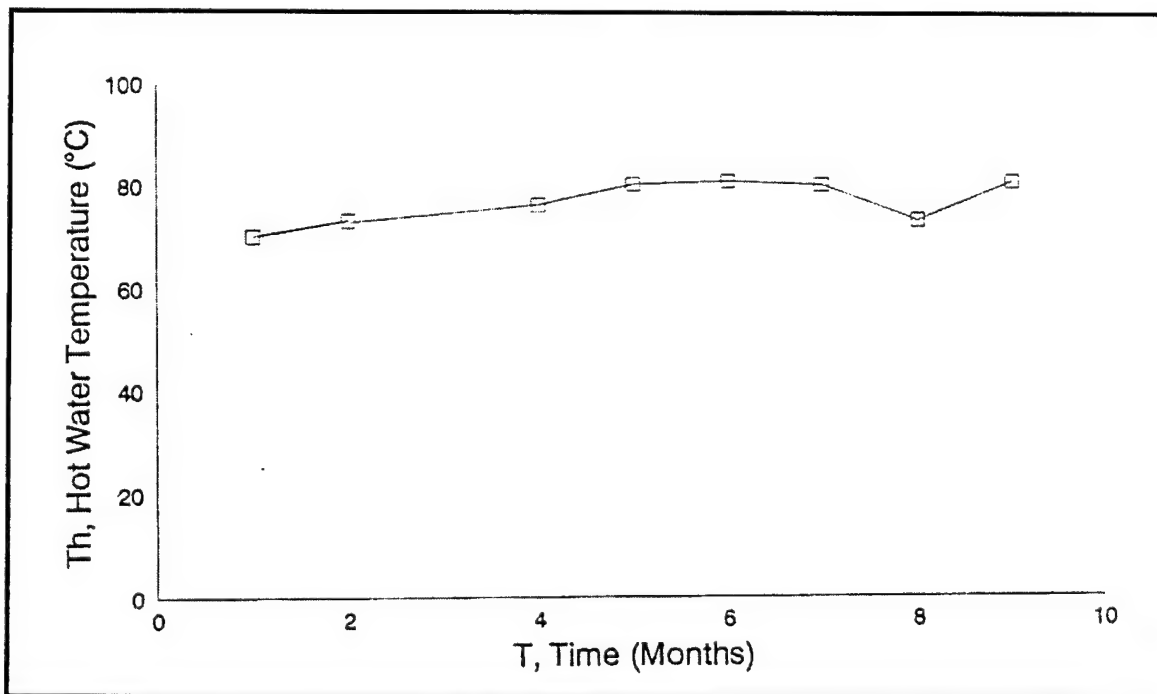
Figures 10 and 11 show field measurements for hot outlet water temperatures at Buildings 3654 and 3657. The data is plotted as monthly averages occurring over a 10-month period starting in December of 1990 and ending in October of 1991. Hot water outlet temperature values shown in Figures 10 and 11 were observed to remain within the range of 64 to 81 °C (147 to 178 °F). The warmest values in each case occurred during the month of September.

Figure 10. Hot outlet water temperatures for phenolic-coated heat exchanger, Bldg 3654, Fort Lewis, WA.

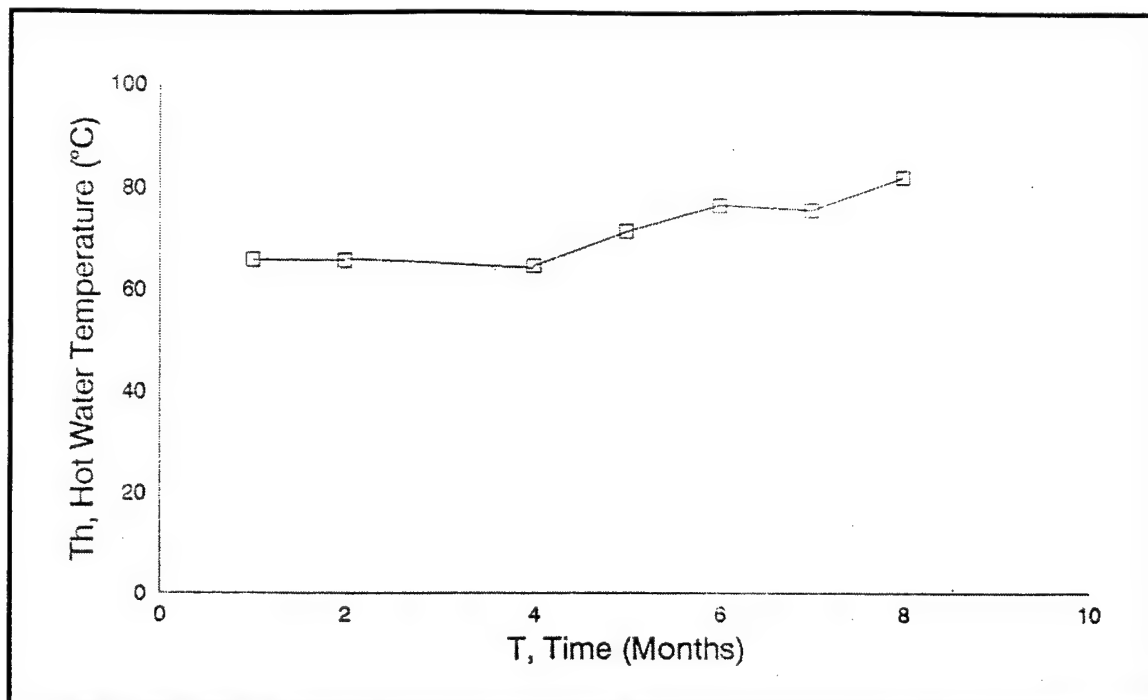
Figure 11. Hot outlet water temperatures for phenolic-coated heat exchanger, Bldg 3657, Fort Lewis, WA.
